EXHIBIT C(I)
TO
DECLARATION OF
MICHAEL A. SOMMER, PH.D.

PRELIMINARY REPORT OF SURVEY

Report no.: N 59116/05

Examined for : The account of whom it may concern.
Requested by : Maersk Sealand, Charleston, SC
(Ms. Trudy Coffey)
Vessel : Margrethe Maersk, Voy. #0506
Date/time survey requested: May 11, 2005 @ 1210 Hours
Date survey commenced : May 12, 2005
Date survey completed : May 12, 2005
Container No. : MAEU 600017-6 (20')
B/L Number : MAEU501016075
Shipment : 15,347 pieces garments
Purpose of Survey: To ascertain the cause and extent of
damage.
Shipper : PYL Apparel Limited
RM 1101-02, 11/F Stelux House
698 Prince Edward Rd. East
Sao Po Kong, KLN
Consignee : To order of Norton McNaughton of Squire
Inc.
Value of Shipment: Unknown

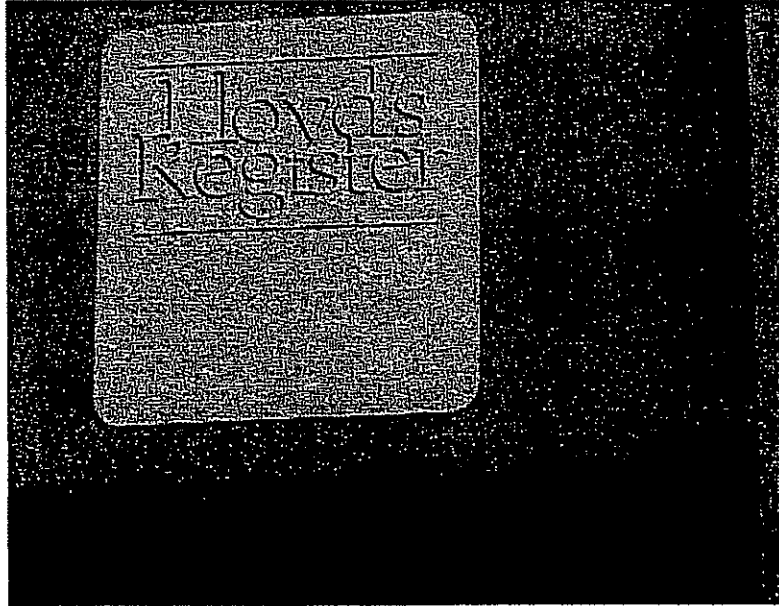
01. A sticker on the side panel of the exterior of the trailer

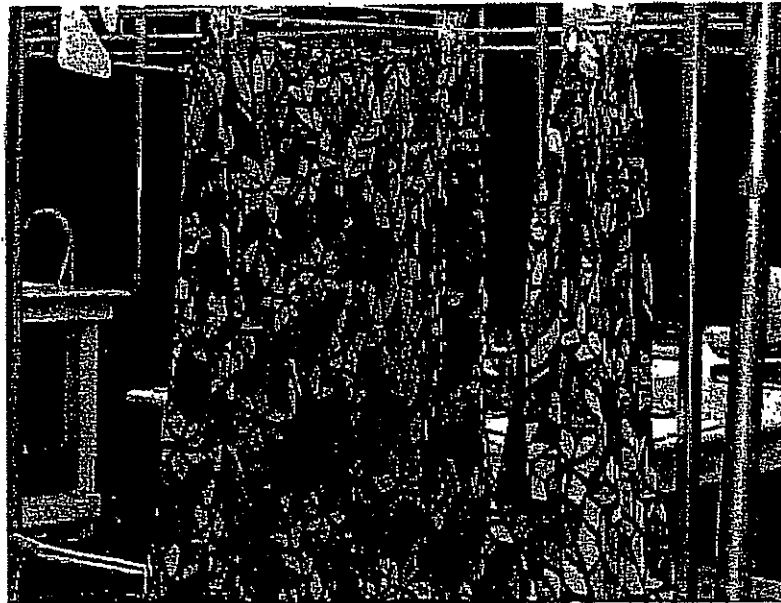
The strong odor could be smelt even from 20-30 feet of the container. The odor appeared stronger at the rear end than at the front of the container. The odor appears to be absorbed within all the garments. Even though the doors had been opened about 2 hours prior to our inspection, the strong odor still prevailed within the container and the cargo. Even dry cleaned pieces of garments retained the odor. We did not see any stains of soil markings on the clothes.

04. Another sample of the clothing that had been aired with the remaining chemical odor

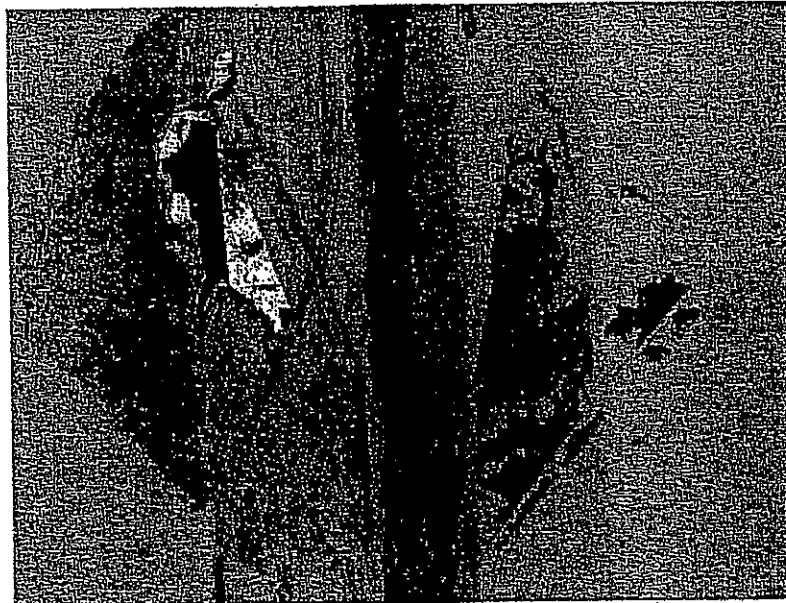
3. Front panel : Old minor dents and rust areas.
4. Door panels
- Right door : No exceptions noted.
Left door : No exceptions noted.
5. Remarks : There were "Flammable/Hazardous" stickers that had been attempted to be removed and parts of the warning stickers were still visible. These stickers were located on left and right panels, as well as the doors.

10. Shows where stickers have been removed

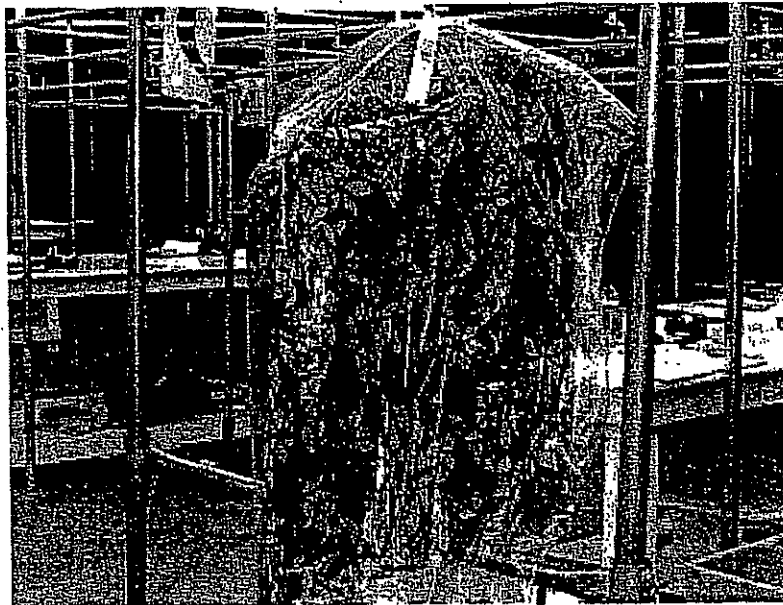
The three samples after dry cleaning still retained the odor even though there were no stains on any of the clothing.

12. The dry cleaned garments with the odor still present

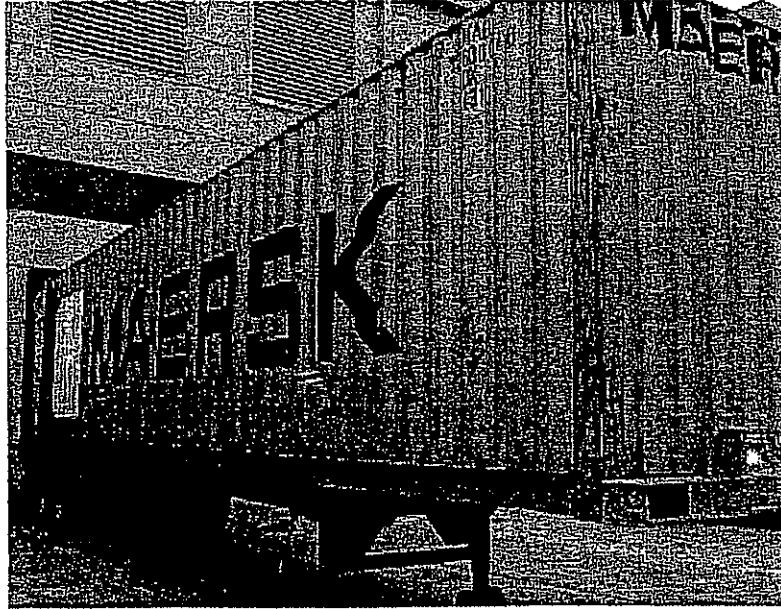
15. The left side from the front showing yellow warning sticker and container number

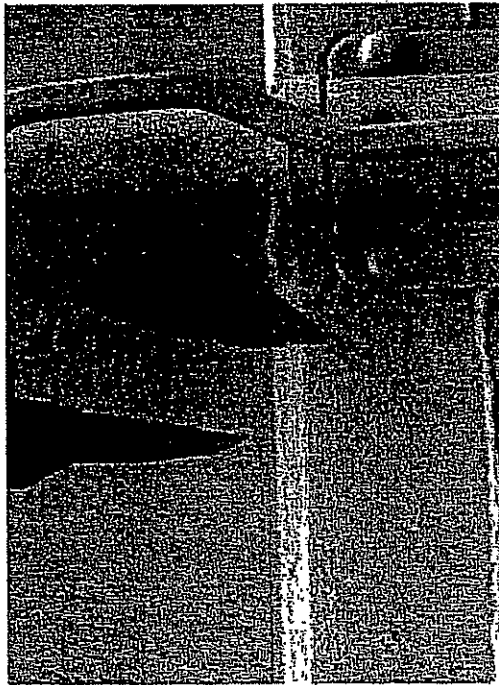
20. Warning sticker on rear of door

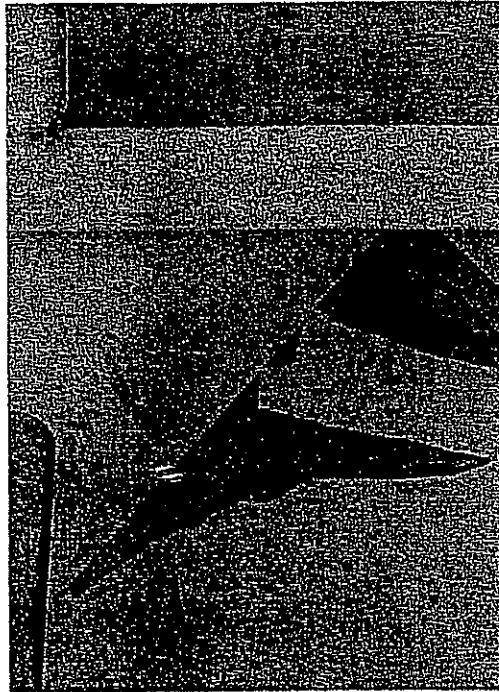
21. Warning sticker on side panel
